HYDRAULIC PUMP DAMAGE

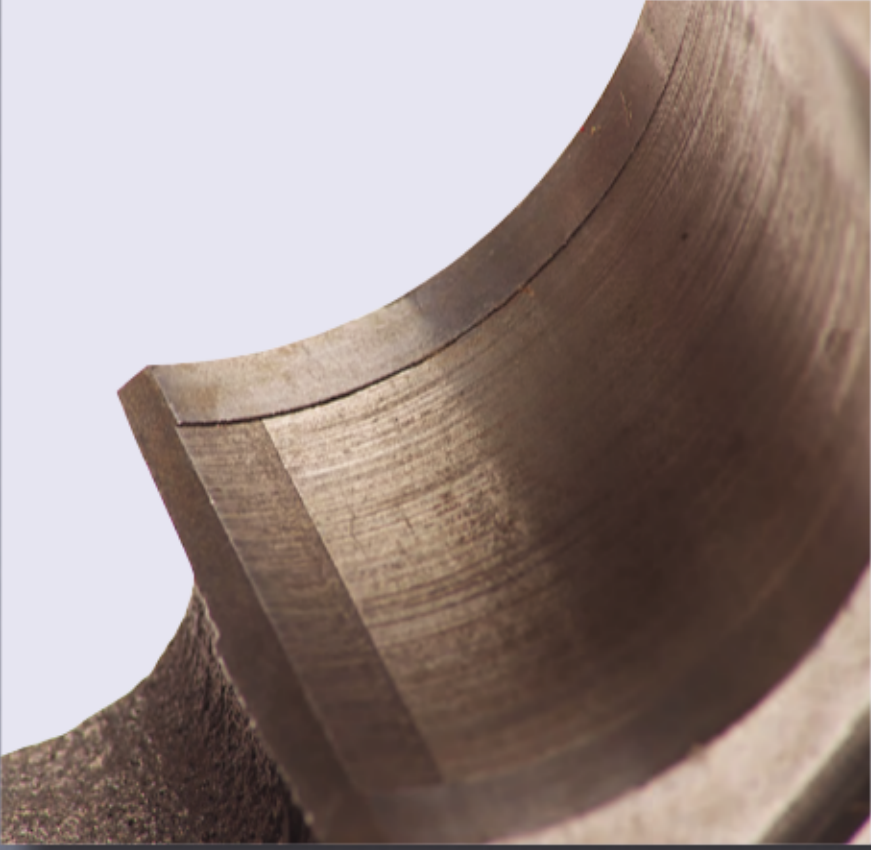
HOUSING CUT OUT

Pump housing cut-out in excess of .005" due to over pressurization.

Pump over pressurization. The pump is being operated beyond its pressure rating or subjected to sudden pressure spikes.

Review application and check against the pump specifications. Check relief valve setting and function. Replace pump or body section.

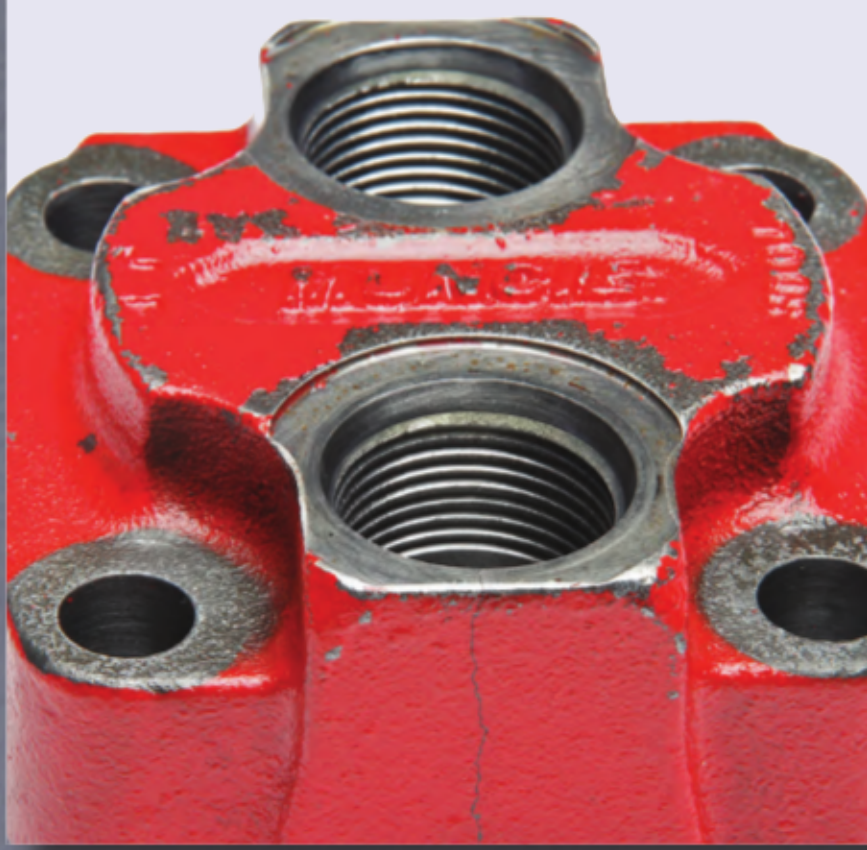
CRACKED HOUSING

Pump body cracked at pressure port due to over pressurization.

Over pressurization. The pump is being operated beyond its pressure rating or subjected to sudden pressure spikes. Can also be caused by overtightening of NPT fittings.

Review application and check against the pump specifications. Check relief valve setting and function. Replace pump or body section. Check torque specification of fittings.

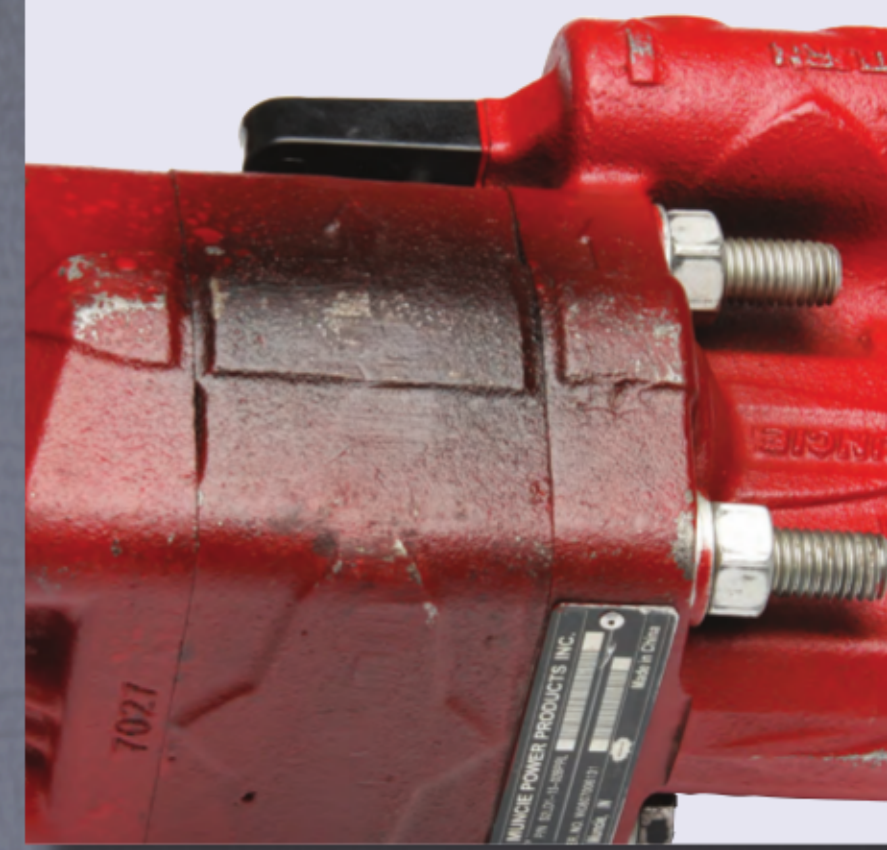
BURNT PUMP BODY

Discoloration of pump body in the gear housing or relief valve area due to excessive heat.

PTO left engaged while truck driven. Two-line dump pump used in continuous duty application. Relief valve set too low or stuck open.

Review application and replace pump. Use automatic PTO kick-out valve. Check relief valve setting and function.

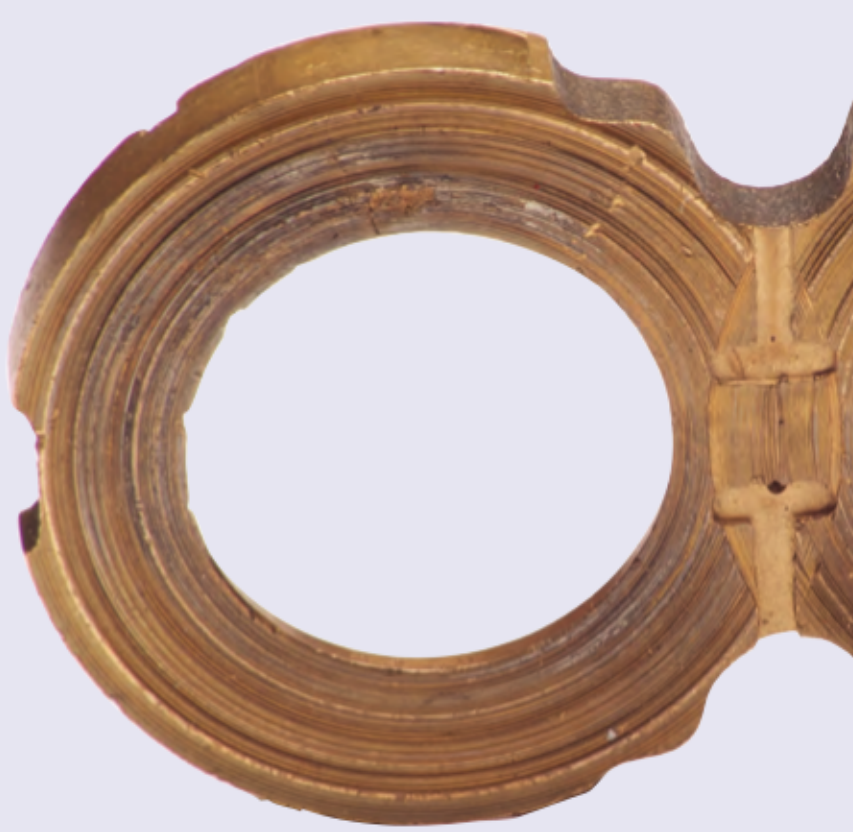
THRUST PLATE PHONOGRAPHING

Circular scoring on thrust plate face resembles the grooves on a record.

Large particle (sand, metal shavings, etc.) contamination.

Replace thrust plates and seals. Flush entire system and replace oil and filters.

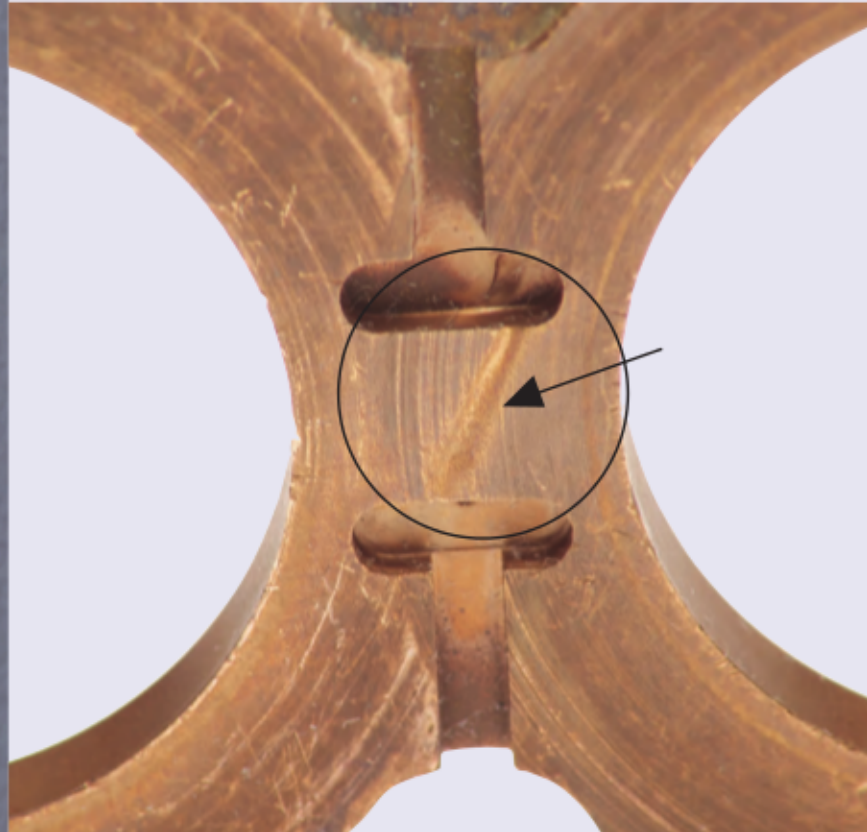
THRUST PLATE JETTING

Diagonal "erosion" on face of thrust plate.

Fine particle contaminates in high concentration.

Replace thrust plates and seals. Flush entire system and replace oil and filters.

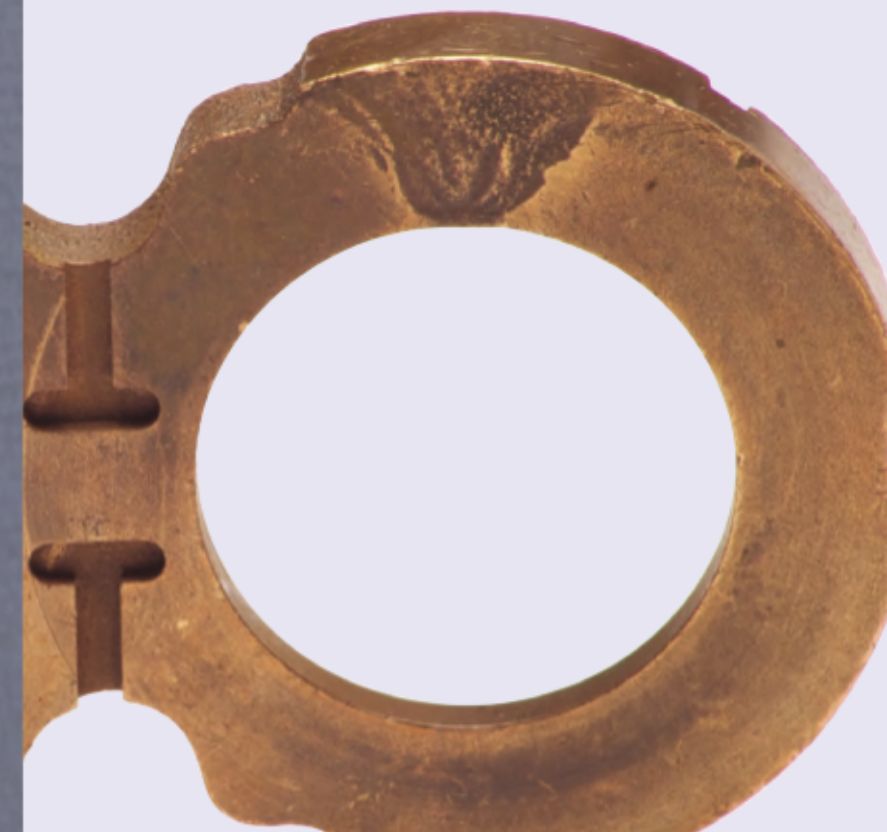
THRUST PLATE PITTING

Pitting of thrust plate surface, often in a "U" shaped pattern. May also occur on the pump body walls.

Excessive vacuum at the pump inlet creates cavitation bubbles which implode on the outlet side of the pump.

Check vacuum at pump inlet. It should not exceed 5 in.Hg. Increase diameter of inlet hose. Clean suction strainer and reservoir breather. Remove suction line filter.

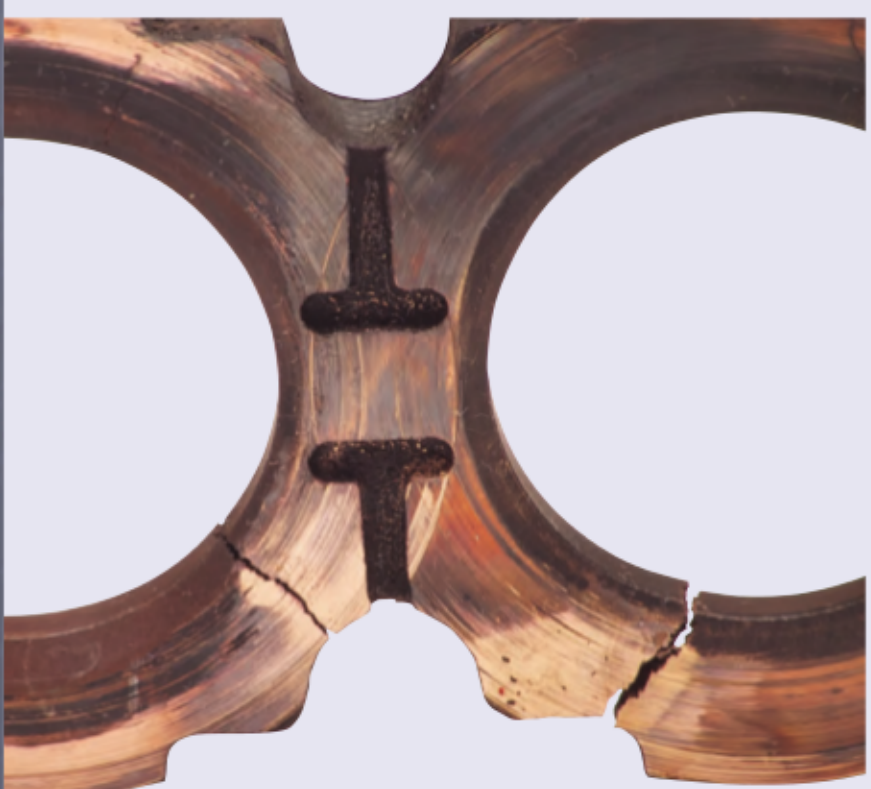
THRUST PLATE CRACKING

Cracks or complete fractures of the thrust plate.

Pump operated beyond its pressure rating or subjected to pressure spikes.

Review application and check against the pump specifications. Check relief valve setting and function.

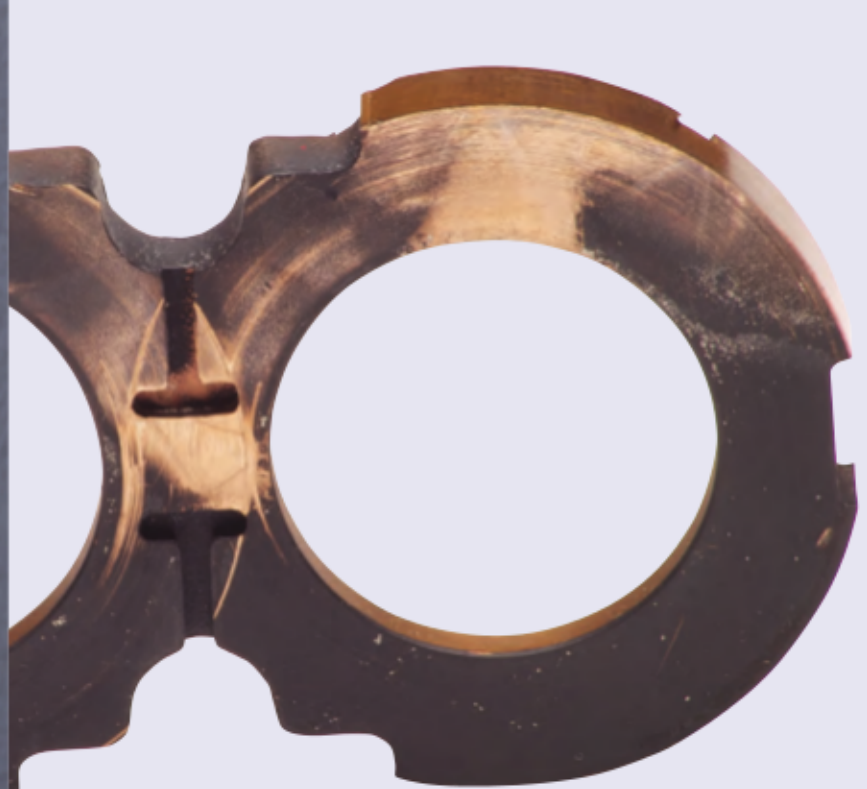
BURNT THRUST PLATE

Thrust plate face is blackened.

Overheating of pump.

Replace thrust plates and all pump seals. Inspect other pump components for damage. Check relief valve setting and function. Heat discoloration is often a secondary symptom of cavitation or contamination damage.

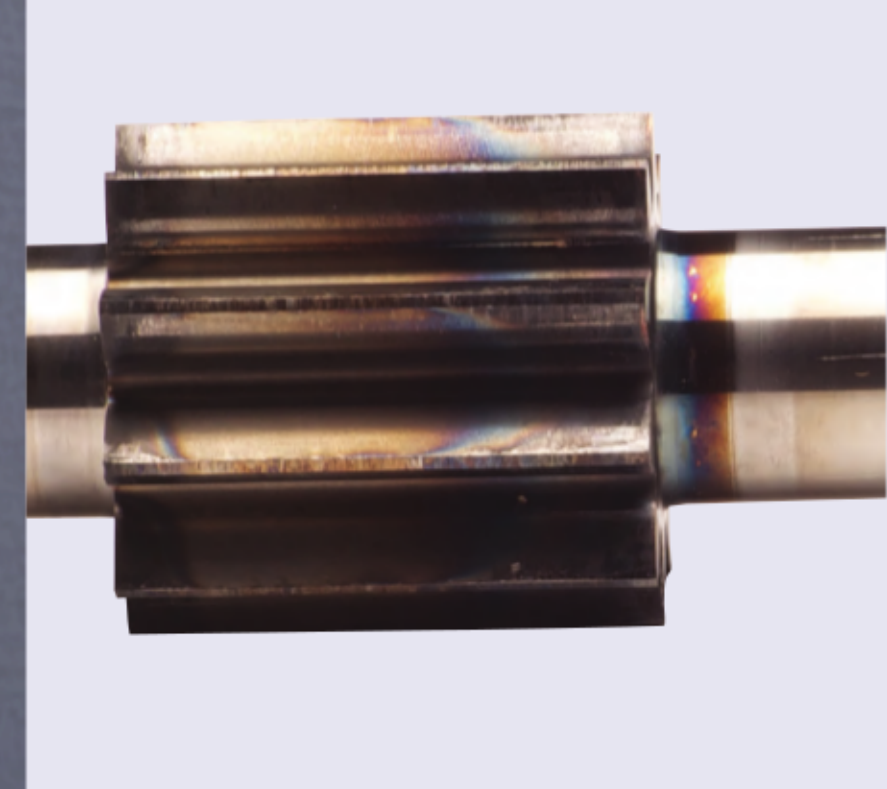
BURNT SHAFT GEAR

Discoloration of gears due to excessive heat.

PTO was left engaged while truck driven. Dump pump used in continuous duty application. Relief valve set too low or stuck open.

Review application and replace pump. Use automatic PTO kick-out valve. Check relief valve setting and function.

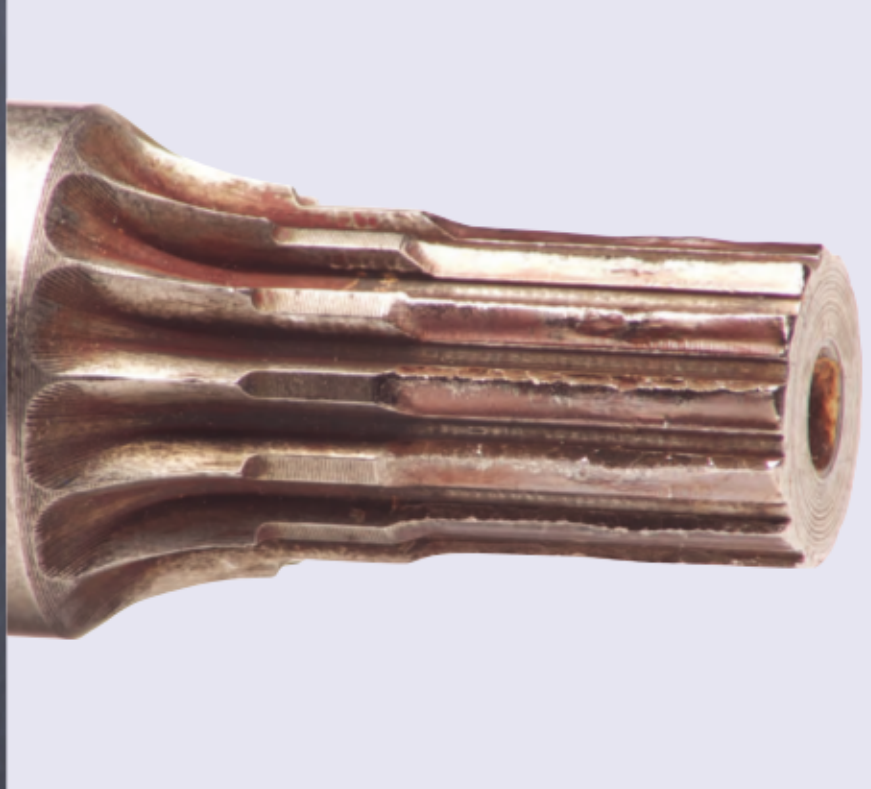
SHAFT SPLINE FRETTING

Worn shaft splines with brownish residue. The PTO shaft splines will show similar wear.

Caused by a combination of a lack of lubrication and harmonic engine vibrations.

Replace pump shaft. Apply lubricant at regular service intervals. Specify Muncie PTO with greaseable output shaft option.

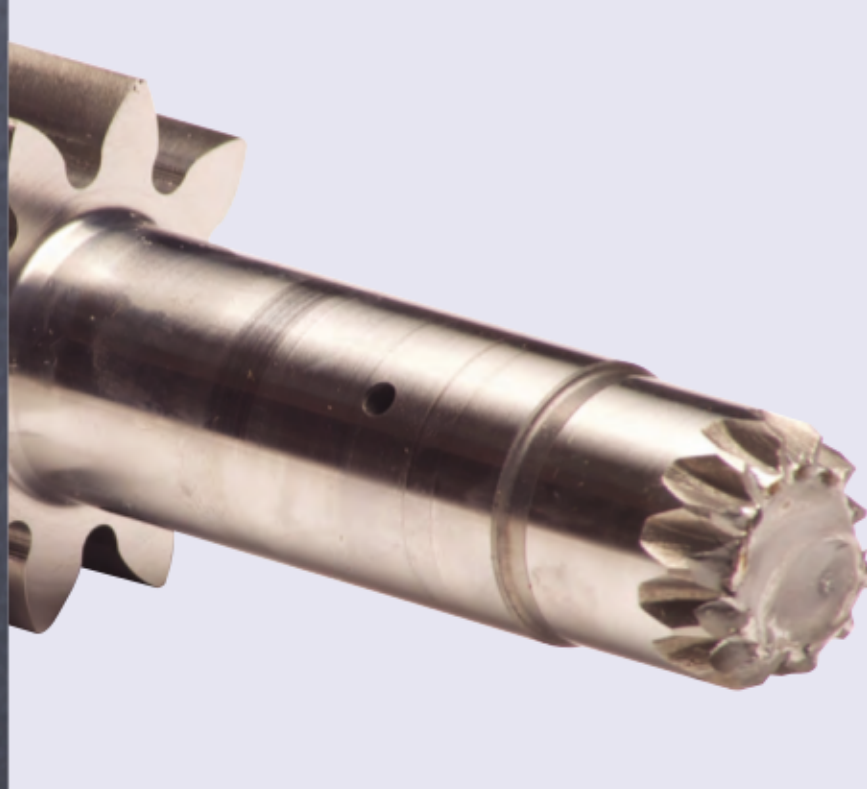
BROKEN/TWISTED SHAFT

Shaft is broken/twisted off at base of spline area.

Excessive operating torque or severe shock load.

Review application and check against the pump specifications. Replace pump shaft. Check operation and setting of system relief valve.

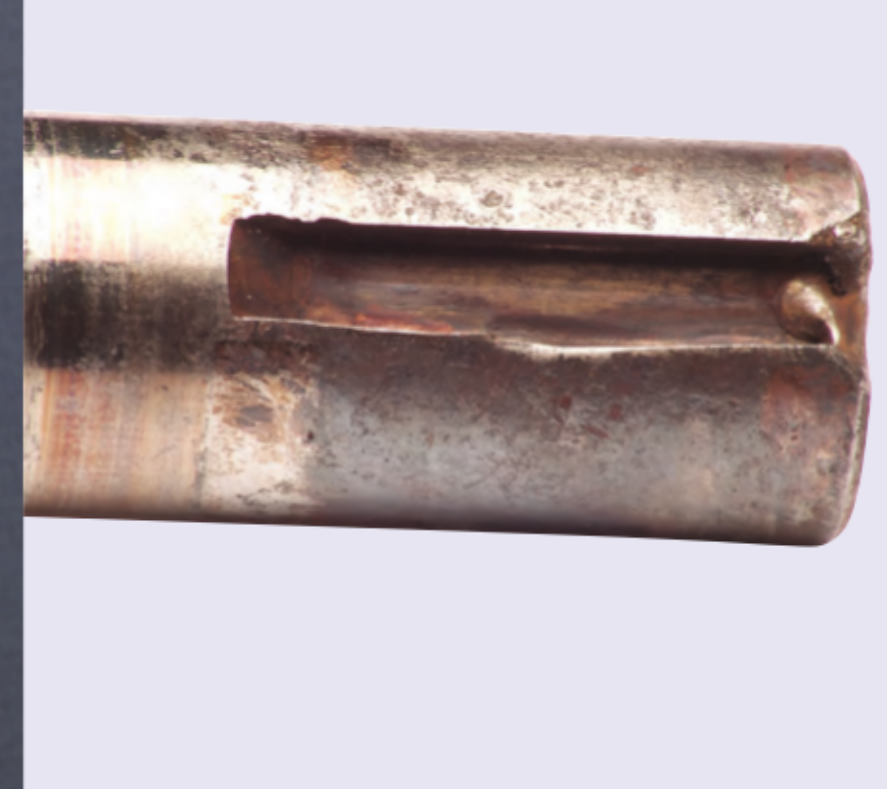
SHAFT KEYWAY DAMAGE

Edges of keyway damaged. Marks where set screw moved under load.

Loose end yoke set screw. Seized slip yoke on driveshaft.

Replace pump input shaft. Repair or replace driveshaft.
