MUNCIE POWER PRODUCTS, INC.

IMPORTANT INSTALLATION INSTRUCTIONS

**INCORRECT FLANGE & BRACKET
ORIENTATION WILL ADVERSELY
AFFECT EXTENDED SHAFT LIFE AND
MAY AFFECT WARRANTY COVERAGE**

**49TA4125A, 49TA4126A, 49TA4127A, 49TA4128A,
49TA4450A & 49TA4999A**

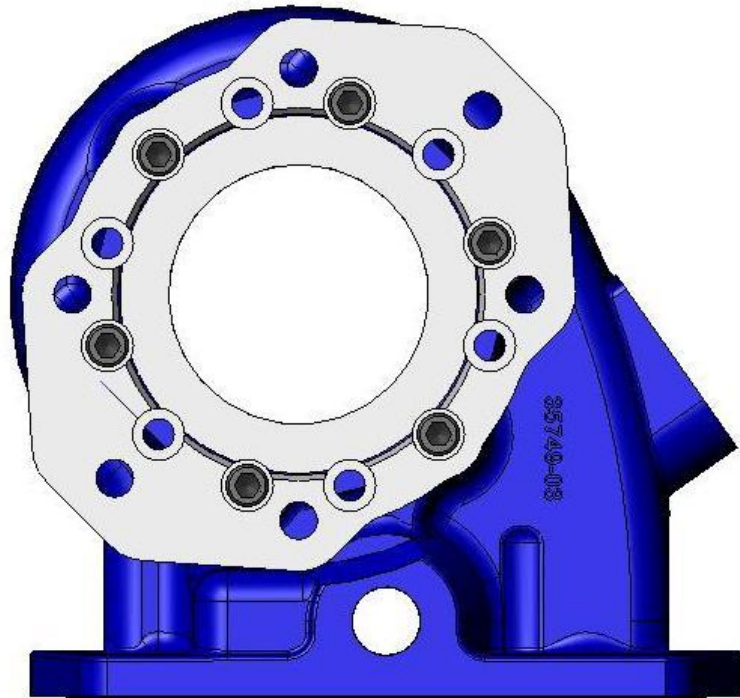
Figure 1

CD10 (A36592) Flange Orientation for Allison 3000 & Left Side Shaft Extension

Check the PTO mounting flange orientation against Figure 1. If needed rotate the PTO flange to match Figure 1.

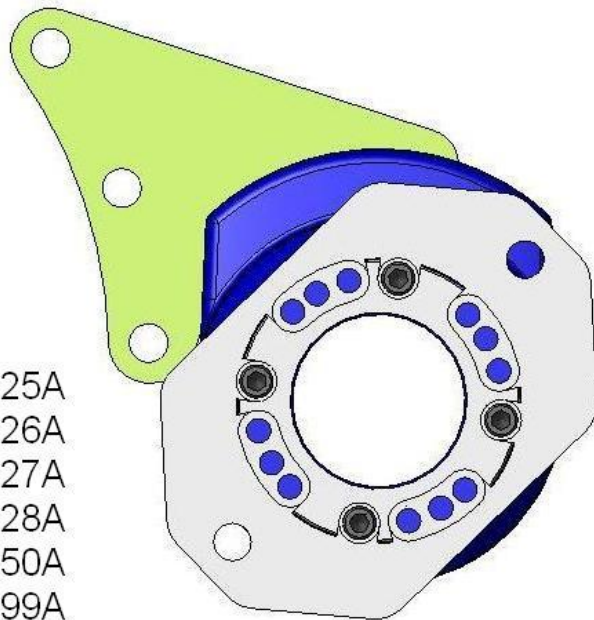
Figure 2

- 49TA4125A
- 49TA4126A
- 49TA4127A
- 49TA4128A
- 49TA4450A
- 49TA4999A

Check the shaft extension mounting flange orientation against Figure 2. If needed rotate the shaft extension flange to match Figure 2.

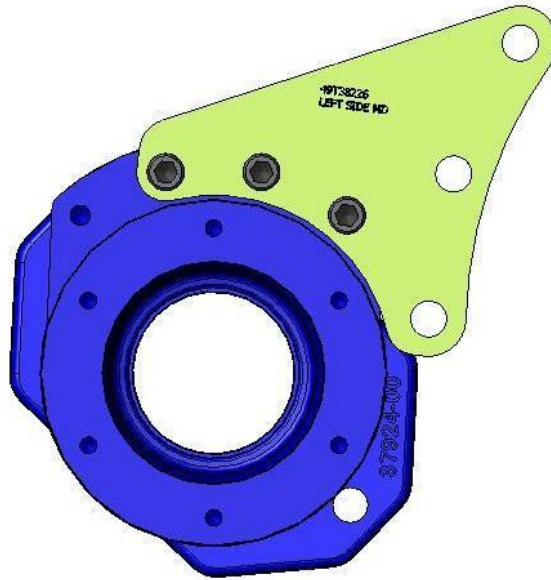
Figure 3

CD10 Left Side Allison 3000 Bracket Orientation

Check the shaft extension mounting bracket orientation against Figure 3. If needed move the shaft extension bracket to match Figure 3.

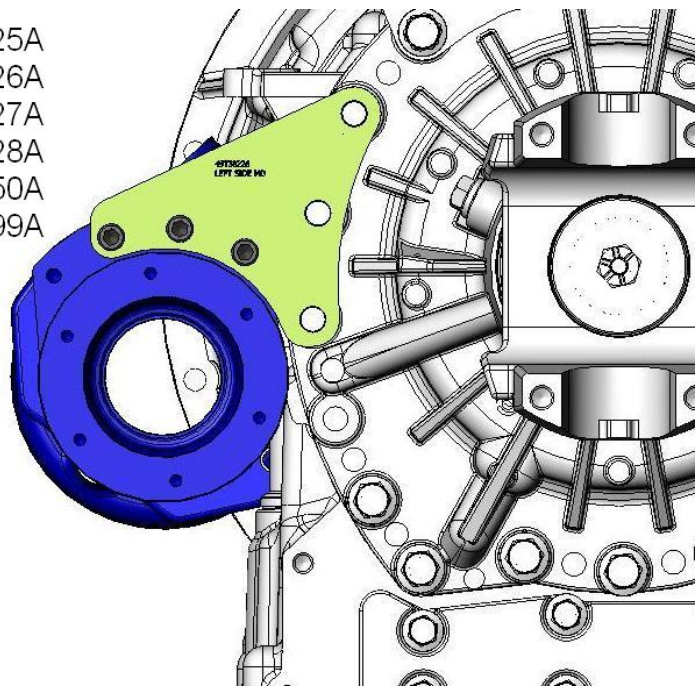
Figure 4

- 49TA4125A
- 49TA4126A
- 49TA4127A
- 49TA4128A
- 49TA4450A
- 49TA4999A

If the bracket bolt holes do not align with the transmission bolt holes similar to Figure 4, recheck to make sure all flange and bracket orientations are as shown in Figures 1-3. If misalignment still exists contact Muncie Power Products for further instructions.
