MUNCIE POWER PRODUCTS, INC.

IMPORTANT INSTALLATION INSTRUCTIONS

**INCORRECT FLANGE & BRACKET
ORIENTATION WILL ADVERSELY
AFFECT EXTENDED SHAFT LIFE AND
MAY AFFECT WARRANTY COVERAGE**

**49TA4133A, 49TA4134A, 49TA4135A, 49TA4137A,
49TA4451A & 49TA5000A**

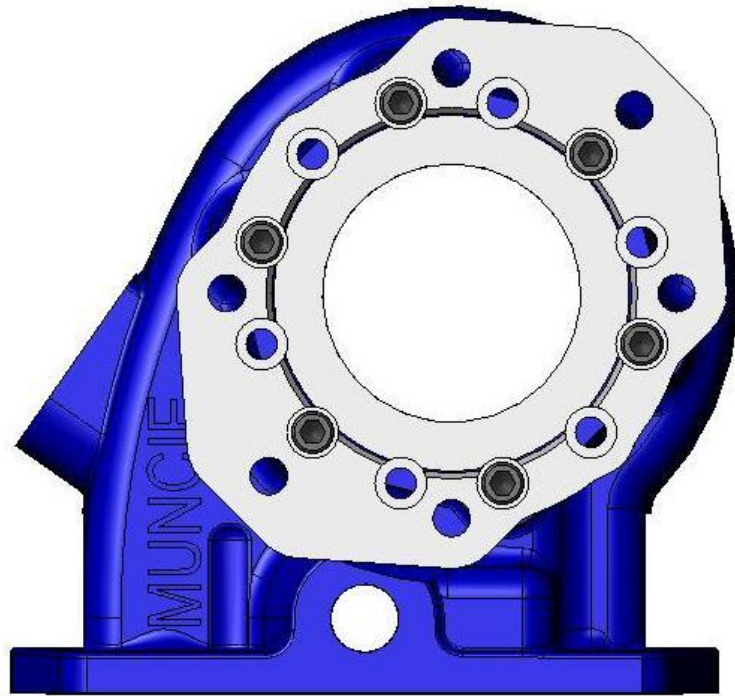
Figure 1

CD10 (A36592) Flange Orientation for Allison 3000 & Right Side Shaft Extension

Check the PTO mounting flange orientation against Figure 1. If needed rotate the PTO flange to match Figure 1.

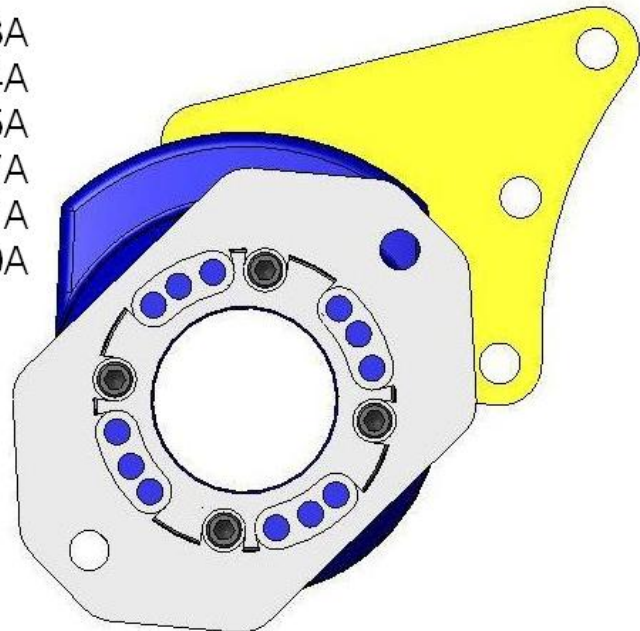
Figure 2

- 49TA4133A
- 49TA4134A
- 49TA4135A
- 49TA4137A
- 49TA4451A
- 49TA5000A

Check the shaft extension mounting flange orientation against Figure 2. If needed rotate the shaft extension flange to match Figure 2.

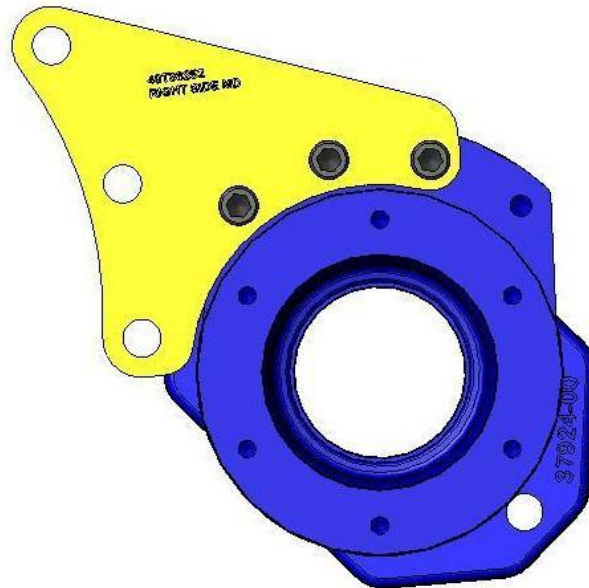
Figure 3

CD10 Right Side Allison 3000 Bracket Orientation

Check the shaft extension mounting bracket orientation against Figure 3. If needed move the shaft extension bracket to match Figure 3.

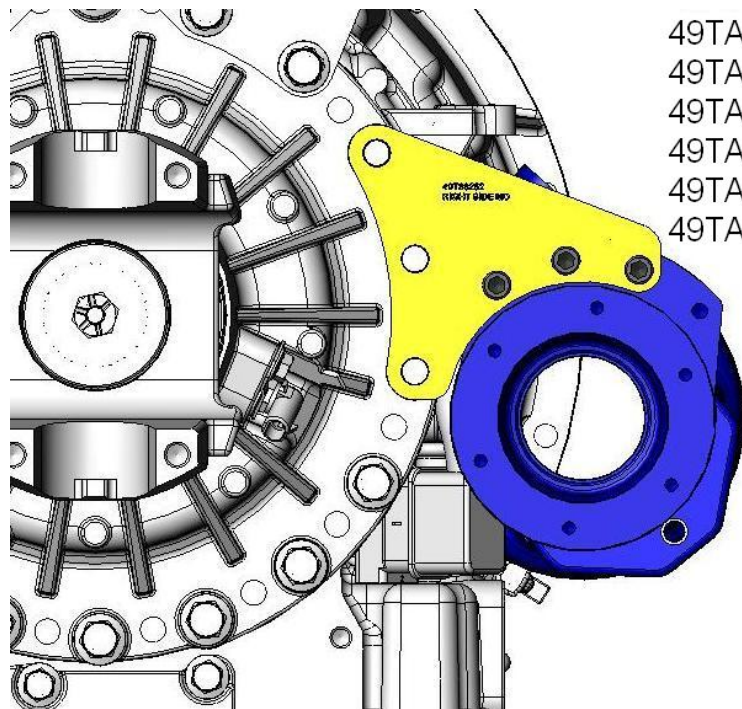
Figure 4

- 49TA4133A
- 49TA4134A
- 49TA4135A
- 49TA4137A
- 49TA4451A
- 49TA5000A

If the bracket bolt holes do not align with the transmission bolt holes similar to Figure 4, recheck to make sure all flange and bracket orientations are as shown in Figures 1-3.

If misalignment still exists contact Muncie Power Products for further instructions.
