## **MUNCIE POWER PRODUCTS, INC.**

## IMPORTANT INSTALLATION INSTRUCTIONS

49TA4877A, 49TA4880A, 49TA4881A & 49TA5004A

I40931 (Rev. 11-07)

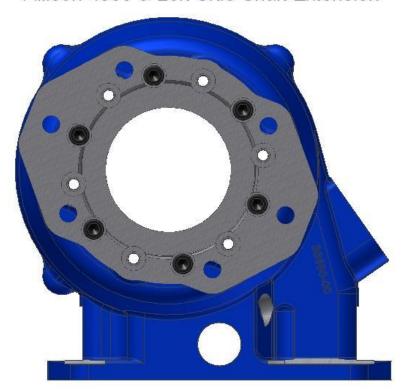
Figure 1

CS41 (A40381) Flange Orientation for Allison 4000 & Left Side Shaft Extension

Check the PTO mounting flange orientation against Figure 1. If needed rotate the PTO flange to match Figure 1.
