## **MUNCIE POWER PRODUCTS, INC.**

## IMPORTANT INSTALLATION INSTRUCTIONS

## INCORRECT FLANGE & BRACKET ORIENTATION WILL ADVERSELY AFFECT EXTENDED SHAFT LIFE AND MAY AFFECT WARRANTY COVERAGE

## SEE ATTACHED PICTURES FOR CORRECT FLANGE & BRACKET ORIENTATION FOR THESE SHAFT EXTENSIONS: 49TA4141A, 49TA4142A, 49TA4207A, 49TA4453A & 49TA4456A

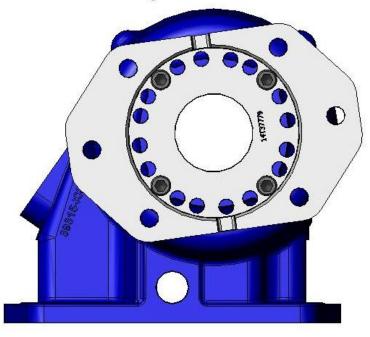
Figure 1

CS20 (A3651) Flange Orientation for Allison 3000 & Right Side Shaft Extension

Check the PTO mounting flange orientation against Figure 1. If needed rotate the PTO flange to match Figure 1.

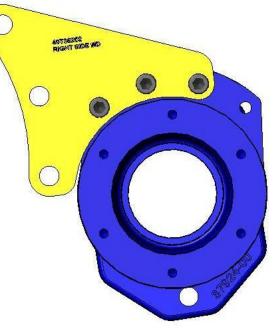
Figure 3

CS20 Right Side Allison 3000 Bracket Orientation

Check the shaft extension mounting bracket orientation against Figure 3. If needed move the shaft extension bracket to match Figure 3.

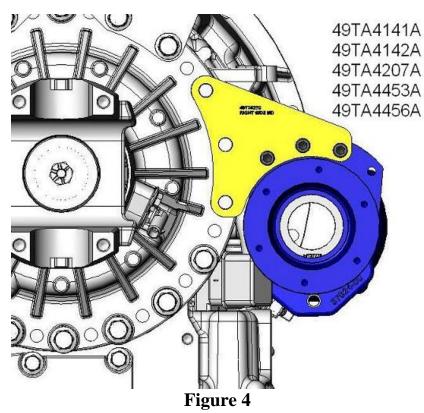
If the bracket bolt holes do not align with the transmission bolt holes similar to Figure 4, recheck to make sure all flange and bracket orientations are as shown in Figures 1-3. If misalignment still exists contact Muncie Power Products for further instructions.
