MUNCIE POWER PRODUCTS, INC.

IMPORTANT INSTALLATION INSTRUCTIONS

**SEE ATTACHED PICTURES FOR CORRECT
FLANGE & BRACKET ORIENTATION FOR THESE
SHAFT EXTENSIONS:**

**49TA4129A, 49TA4130A, 49TA4131A, 49TA4132A,
49TA4432A & 49TA4941A**

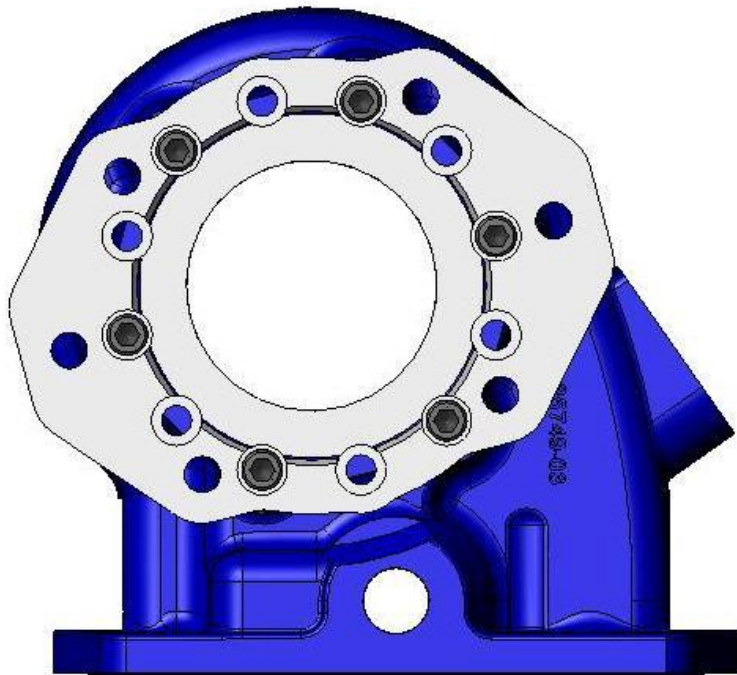
Figure 1

Check the PTO mounting flange orientation against Figure 1. If needed rotate the PTO flange to match Figure 1.

CD10 (A36592) Flange Orientation for Allison 4000 & Left Side Shaft Extension

If the bracket bolt holes do not align with the transmission bolt holes similar to Figure 4, recheck to make sure all flange and bracket orientations are as shown in Figures 1-3. If misalignment still exists contact Muncie Power Products for further instructions.

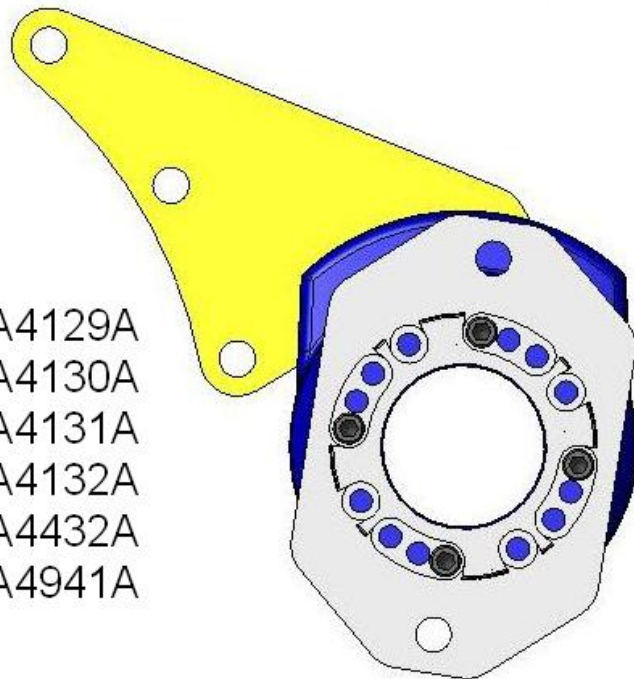
Figure 2

Check the shaft extension mounting flange orientation against Figure 2. If needed rotate the shaft extension flange to match Figure 2.

- 49TA4129A
- 49TA4130A
- 49TA4131A
- 49TA4132A
- 49TA4432A
- 49TA4941A

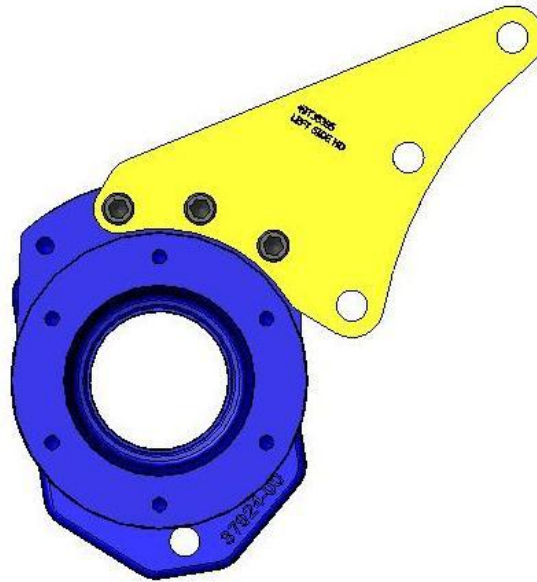
Figure 3

Check the shaft extension mounting bracket orientation against Figure 3. If needed move the shaft extension bracket to match Figure 3.

CD10 Left Side Allison 4000 Bracket Orientation
