## **MUNCIE POWER PRODUCTS, INC.**

## IMPORTANT INSTALLATION INSTRUCTIONS

SEE ATTACHED PICTURES FOR CORRECT FLANGE & BRACKET ORIENTATION FOR THESE SHAFT EXTENSIONS:

49TA4833A, 49TA4834A, 49TA4835A, 49TA4840A, 49TA4875A, 49TA4898A & 49TA5003A

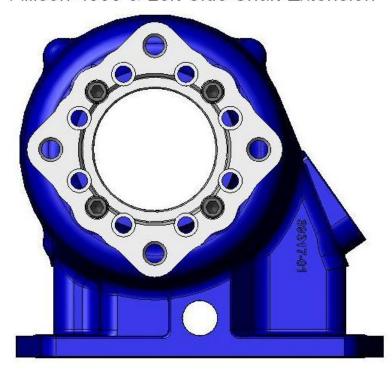
Figure 1

Check the PTO mounting flange orientation against Figure 1. If needed rotate the PTO flange to match Figure 1.

CS20 (A38550) Flange Orientation for Allison 4000 & Left Side Shaft Extension

If the bracket bolt holes do not align with the transmission bolt holes similar to Figure 4, recheck to make sure all flange and bracket orientations are as shown in Figures 1-3. If misalignment still exists contact Muncie Power Products for further instructions.

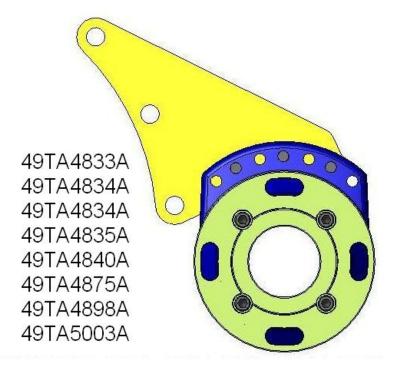
Figure 2

Check the shaft extension mounting flange orientation against Figure 2. If needed rotate the shaft extension flange to match Figure 2.

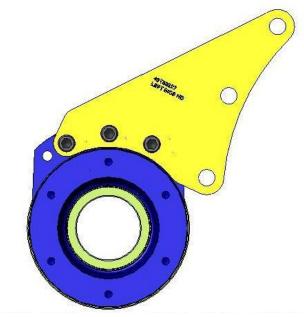
Figure 3

Check the shaft extension mounting bracket orientation against Figure 3. If needed move the shaft extension bracket to match Figure 3.

## CS20 Left Side Allison 4000 Bracket Orientation
